Review of Diamond SR RF Operation and Upgrades

Morten Jensen
on behalf of
Diamond Storage Ring RF Group

Cavity 2 Failure

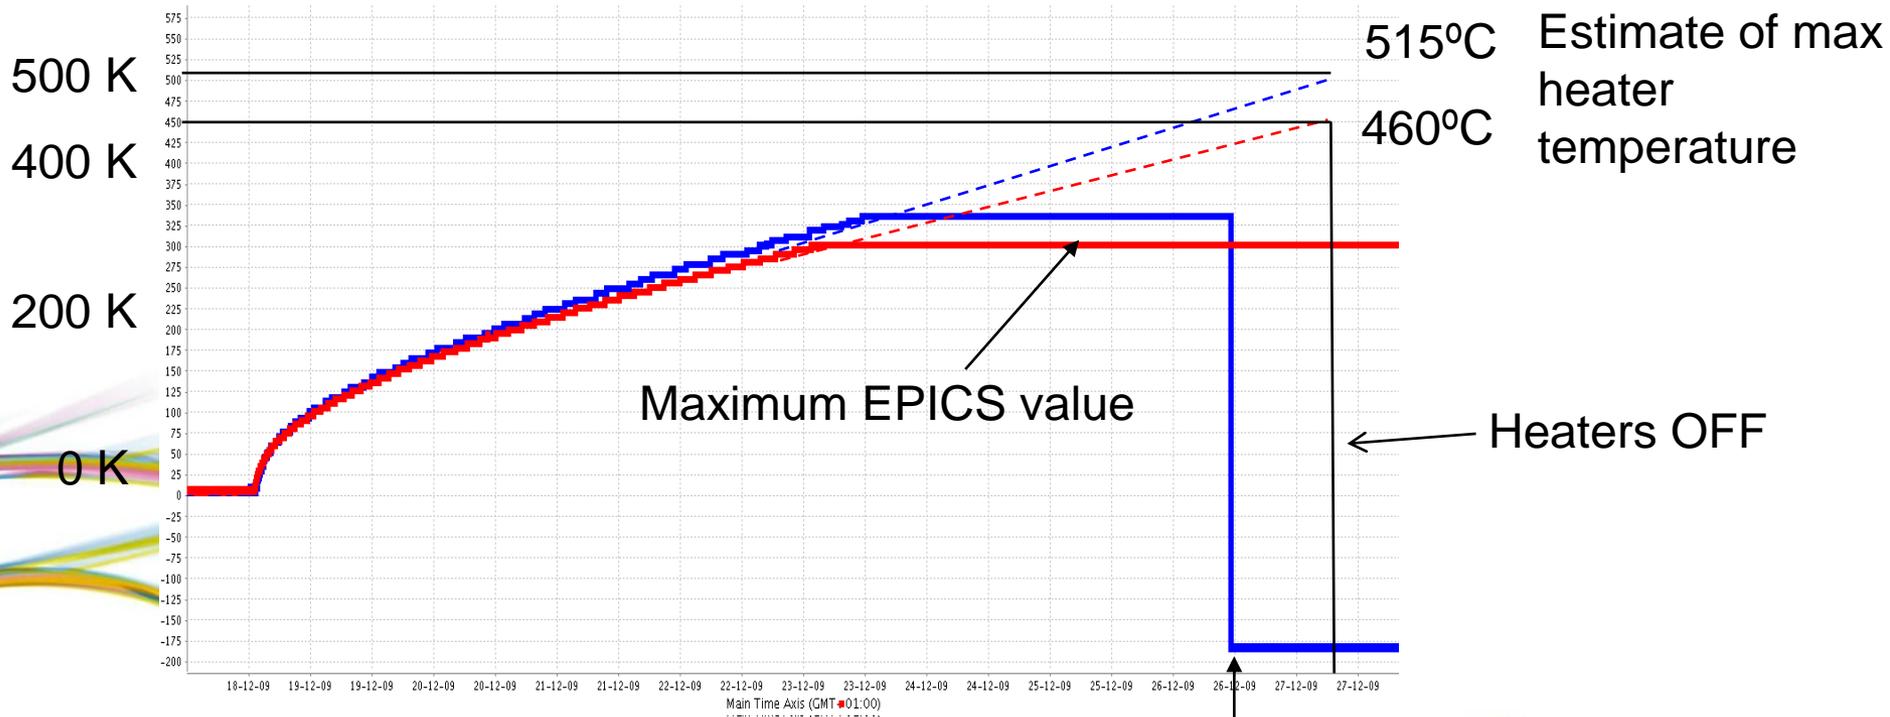
CLTS on Cavity 2 Fail

Cavities 1 and 2 installed and being warmed up over Christmas. Warming up the cavities requires the use of electrical heaters. Procedure and Manual did not include turning off heaters. Heaters were not interlocked.

→ **Heaters were left on!**

First sign: Leak from helium can to insulation vacuum

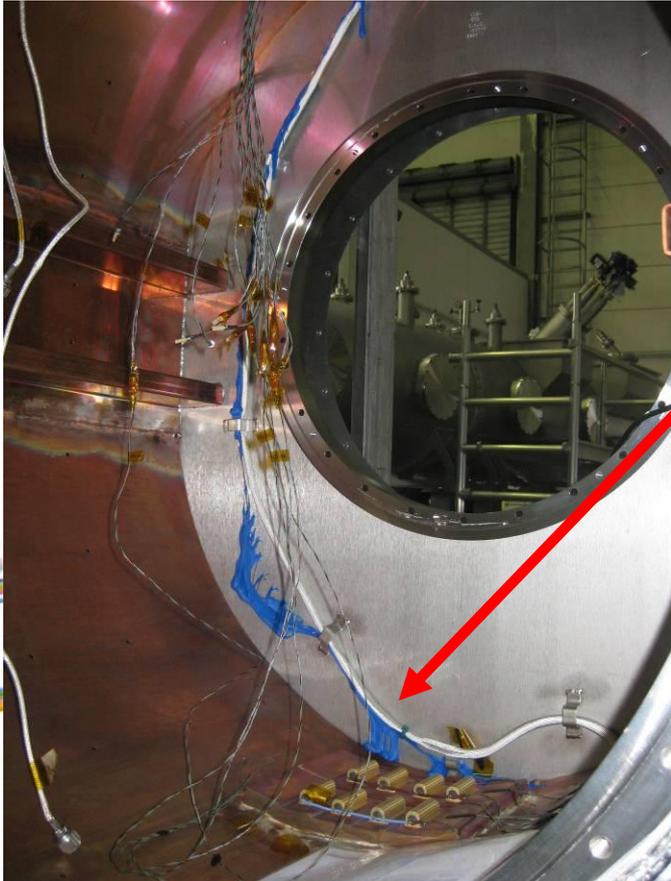
Helium level probes with blue 'plastic' insulation which has melted

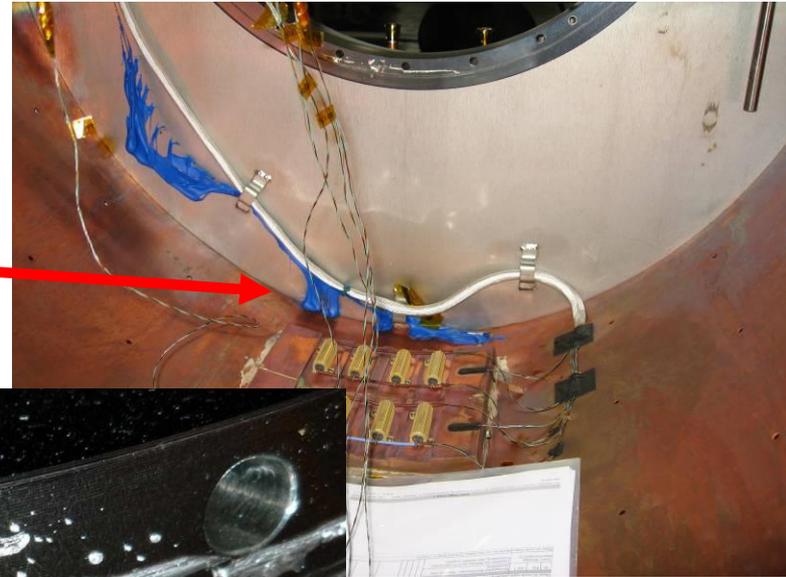
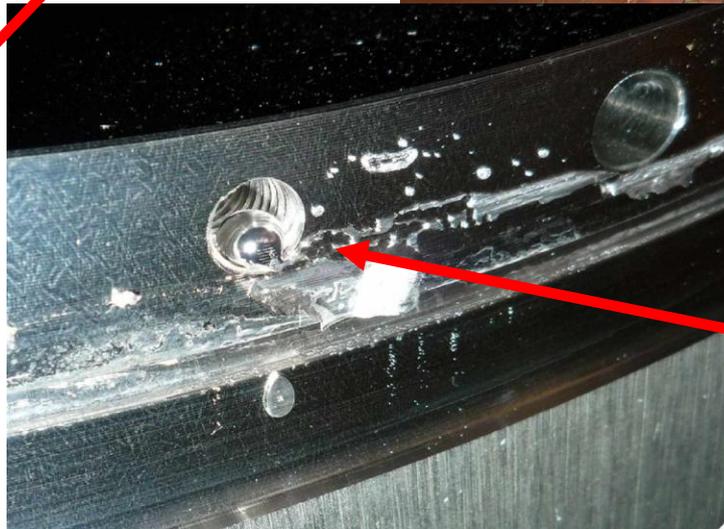
Vacuum seal has failed and indium has melted

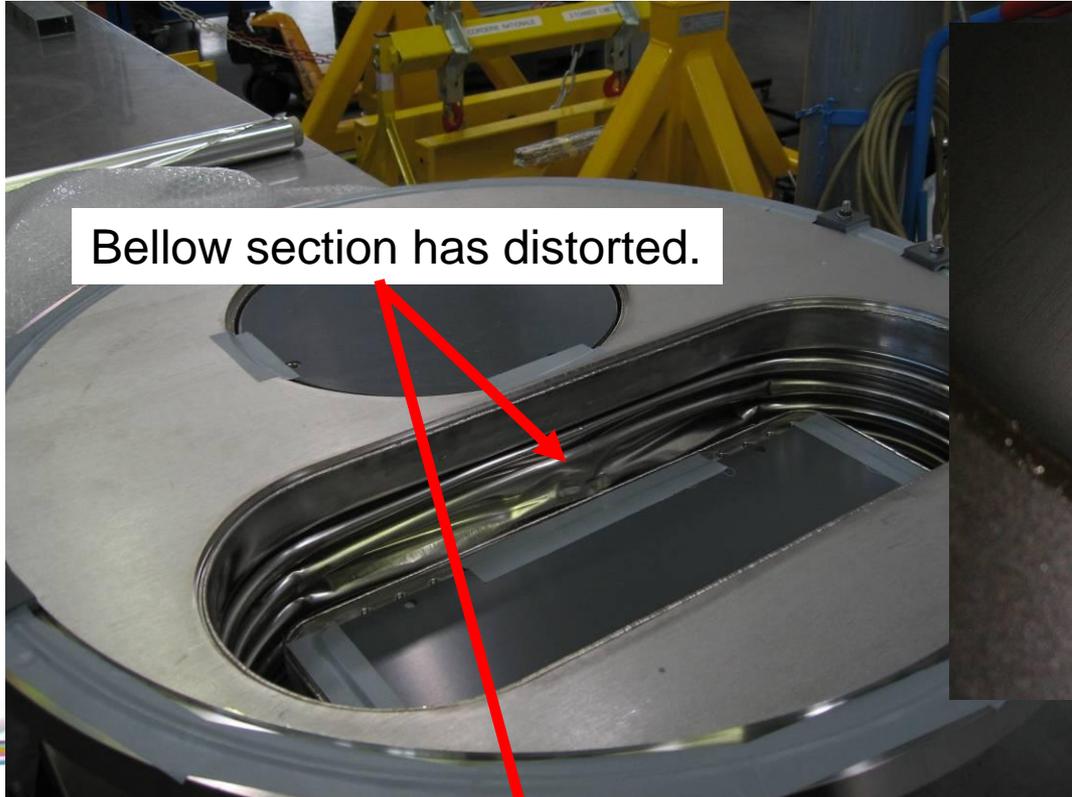
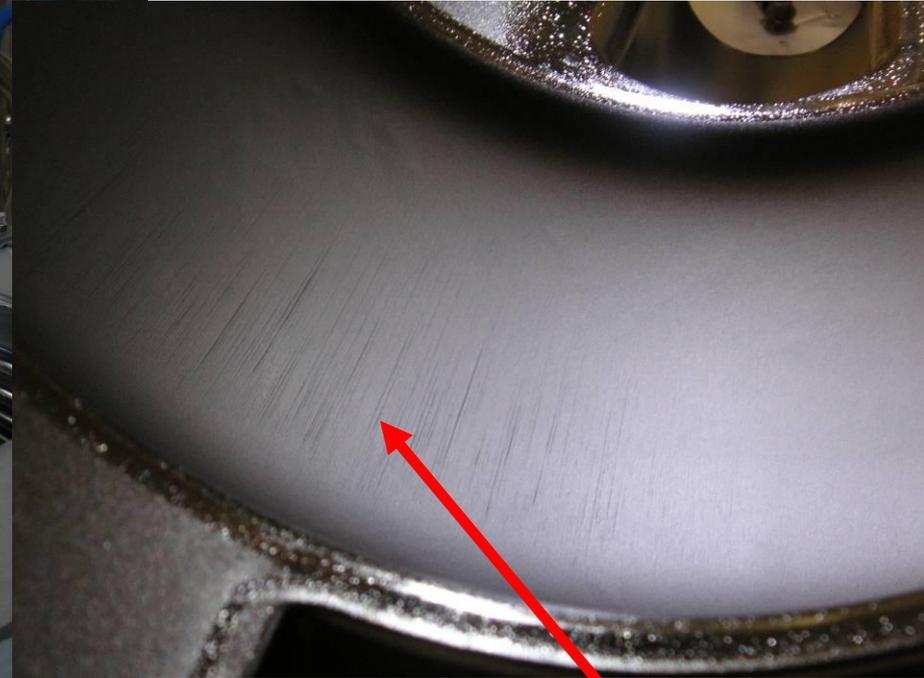
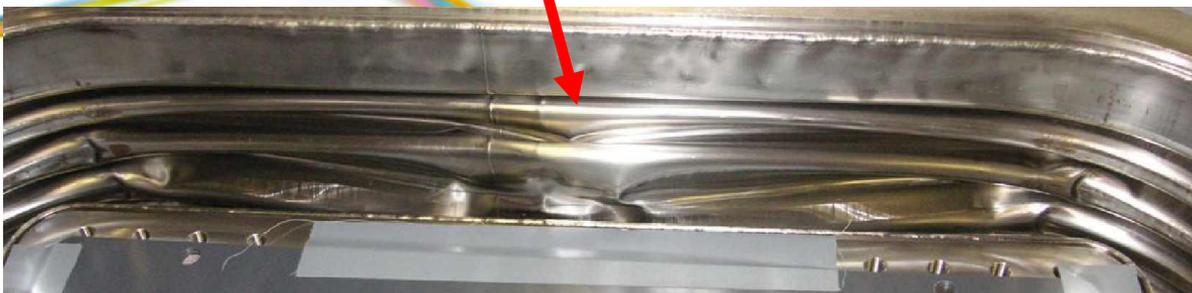
Radial groove from original BCP etch

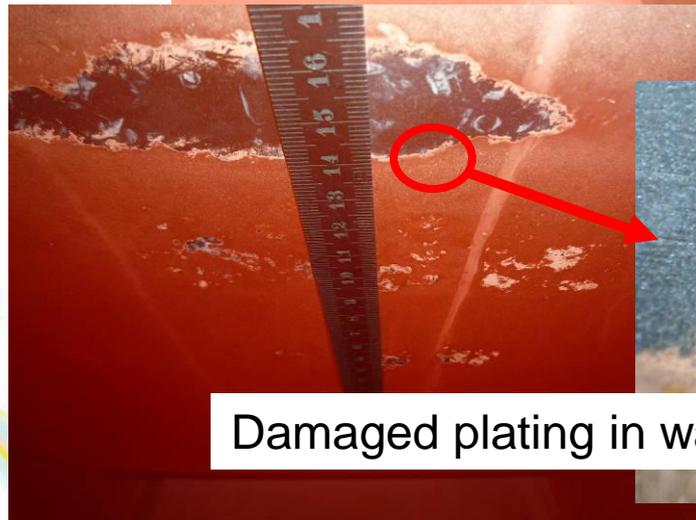
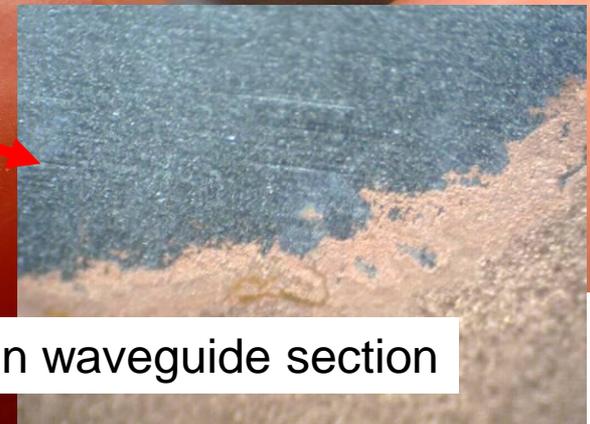
Damaged plating in waveguide section

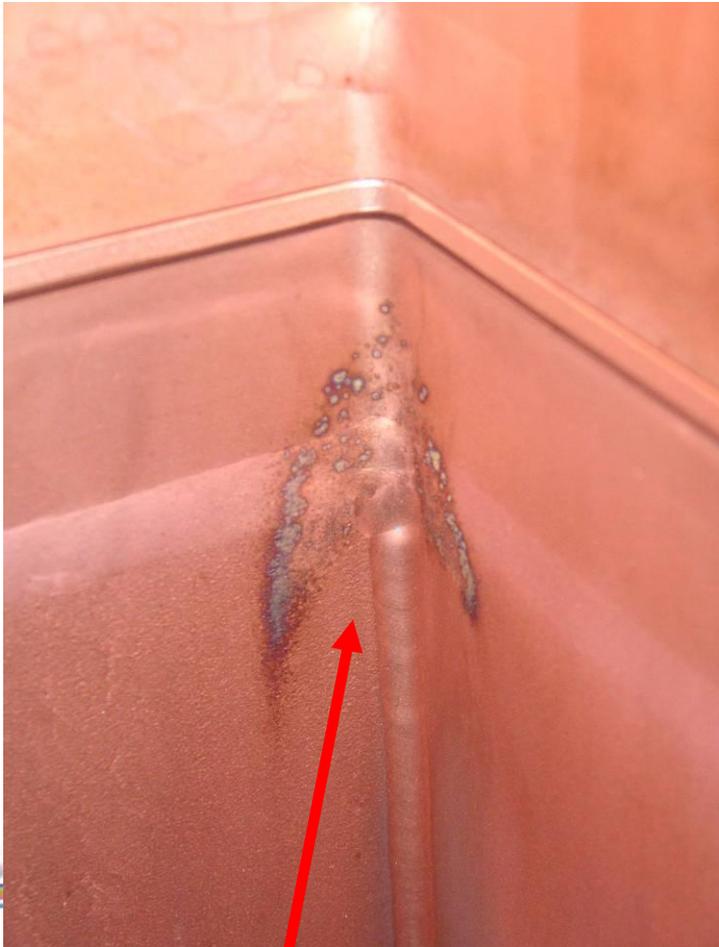
Discolouration of waveguide components and of the gasket

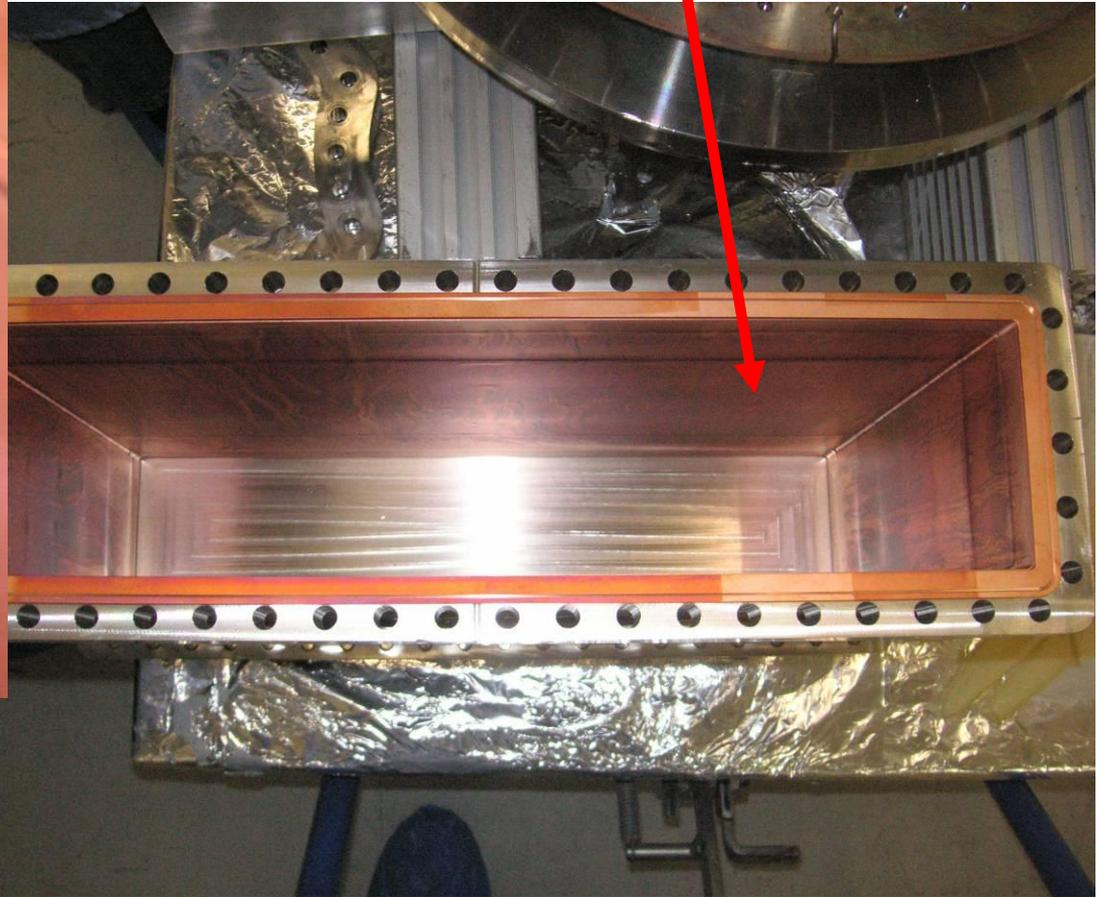
Staining or damaged plating in the corners of the waveguide

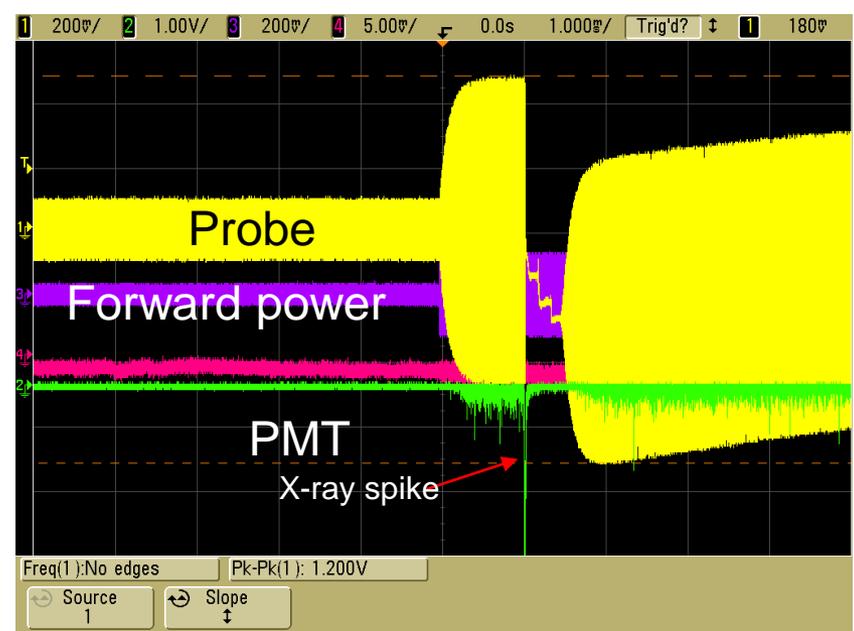
PMT signal showing probe blip

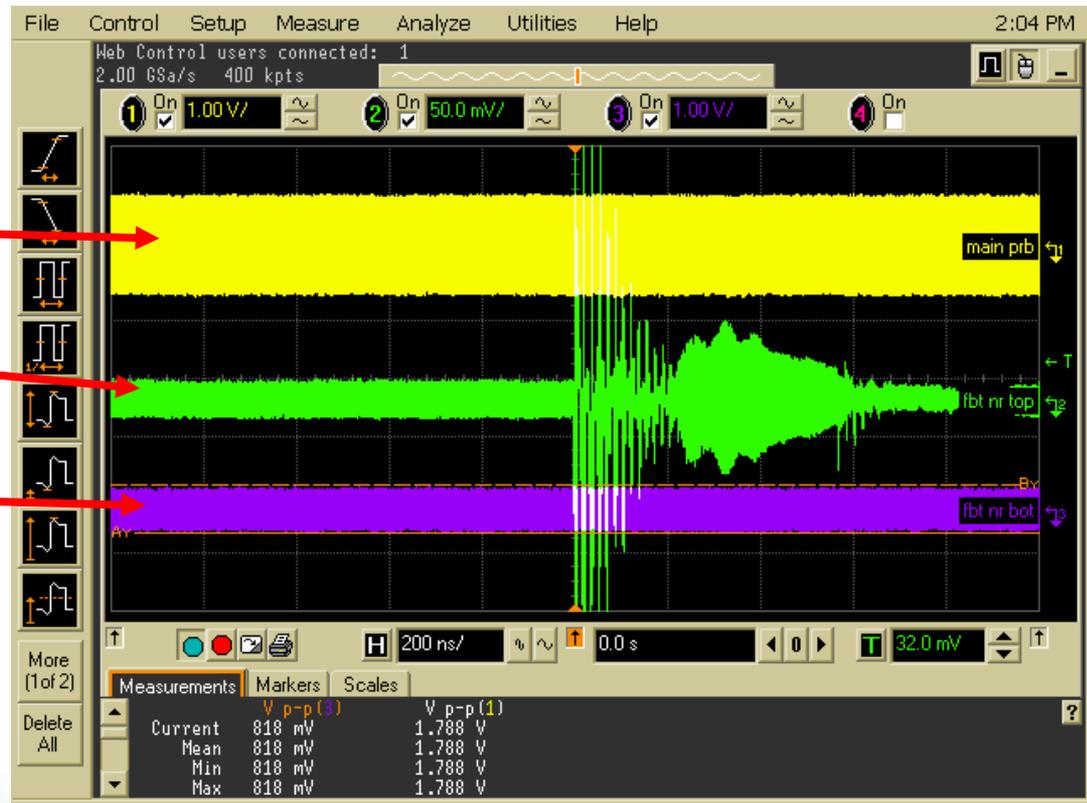
Probe problem

1. Main probe and e- pickup have failed.
2. Cavity 2 and 3 both suffer probe blips. Cavity 1 under investigation.
3. Probe blips happen with and without beam.
4. Probes don't have blips at the same time.
5. Probe blips don't always trip the beam.
6. Very high amplitude.
7. Not successful to filter it out. (Band pass filter, DC block)
8. Not successful with bias voltage.

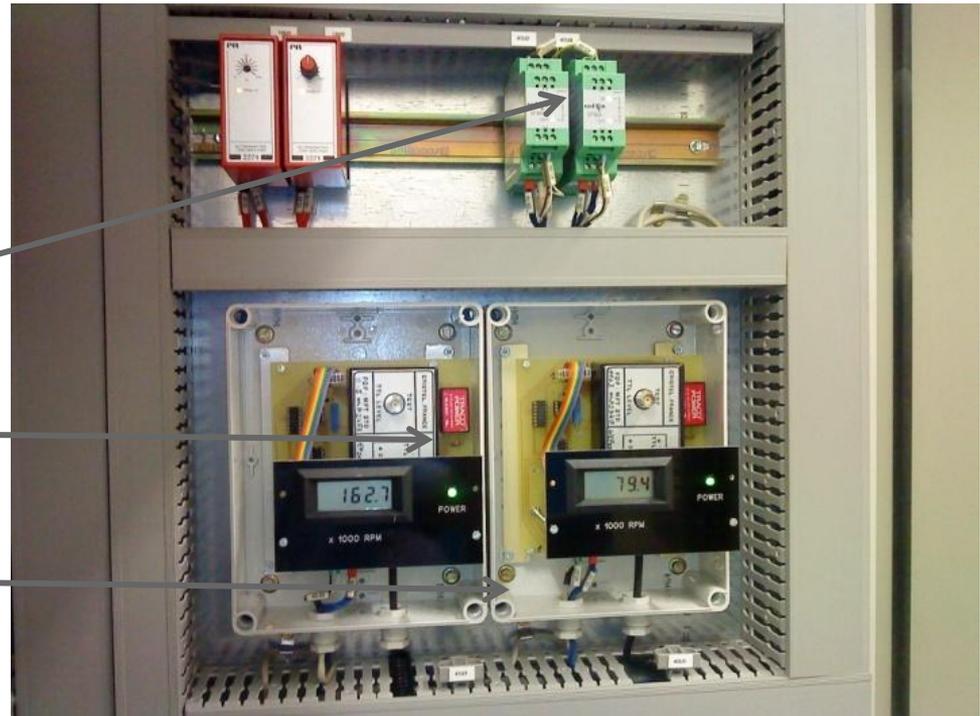
Speed sensing of the warm turbine has occasionally become erratic without prior warning.

After ensuring that the fibre optic cable was properly mounted, part of the signal conditioning box was changed.

The problem reoccurred. The frequency to analogue converter was then replaced. There has been no reoccurrence.
