Radiation Safety issues for the PF-AR in KEK

H. Nakamura, Y. Namito, K. Iijima, K.
Takahashi and S. Ban

*High Energy Accelerator Research
Organization (KEK)*

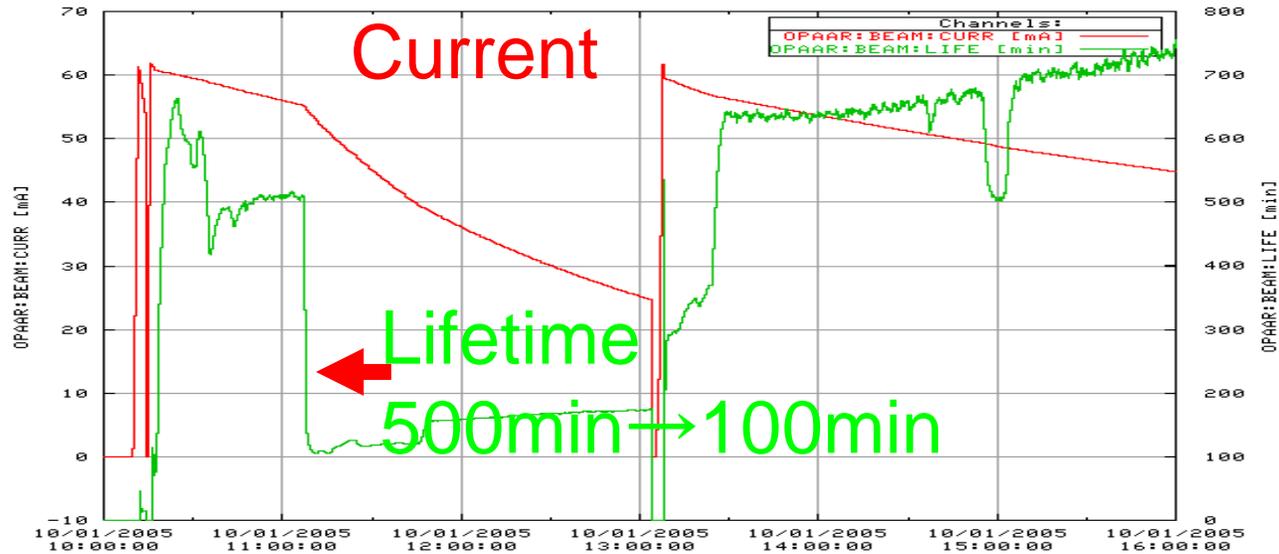
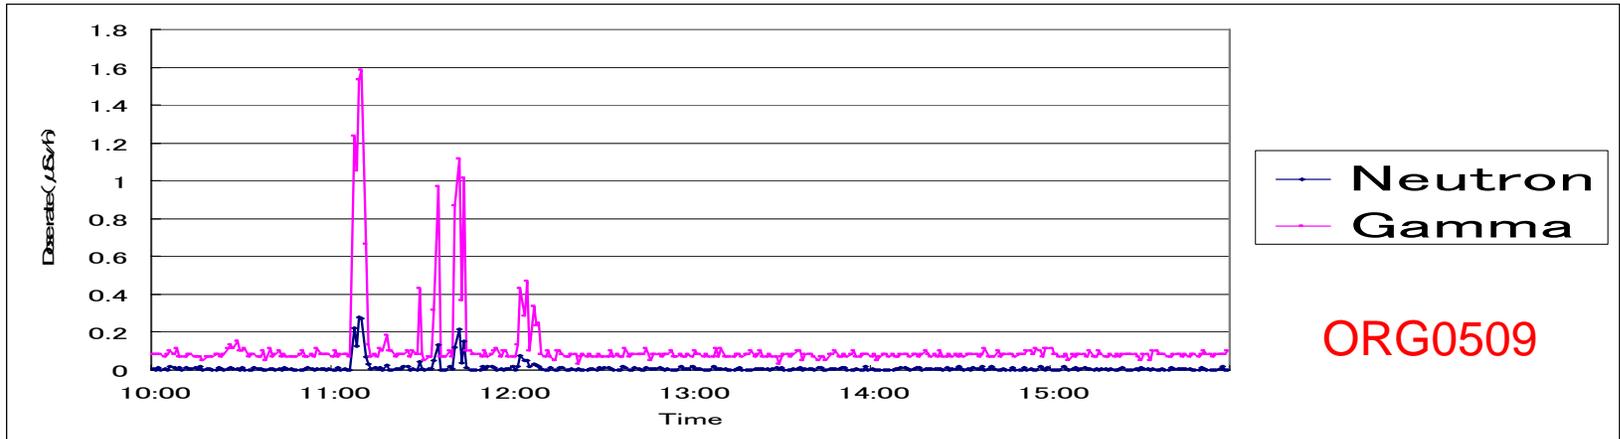
Sudden drop of the beam lifetime and increase of dose rate

- Usual dose rate \doteq Background level
- Dose rate over the background level occurred when the **beam lifetime decreased**.
- Next slide shows example of this phenomenon occurred at the beam line NW12.

- Radiation source was the upper of NW12.
- Maximum dose rate at ORG509 was $1.6 \mu\text{ Sv/h}$.
- **ORG509** was **at long distance** from the radiation source. We tried to measure near the beam line.

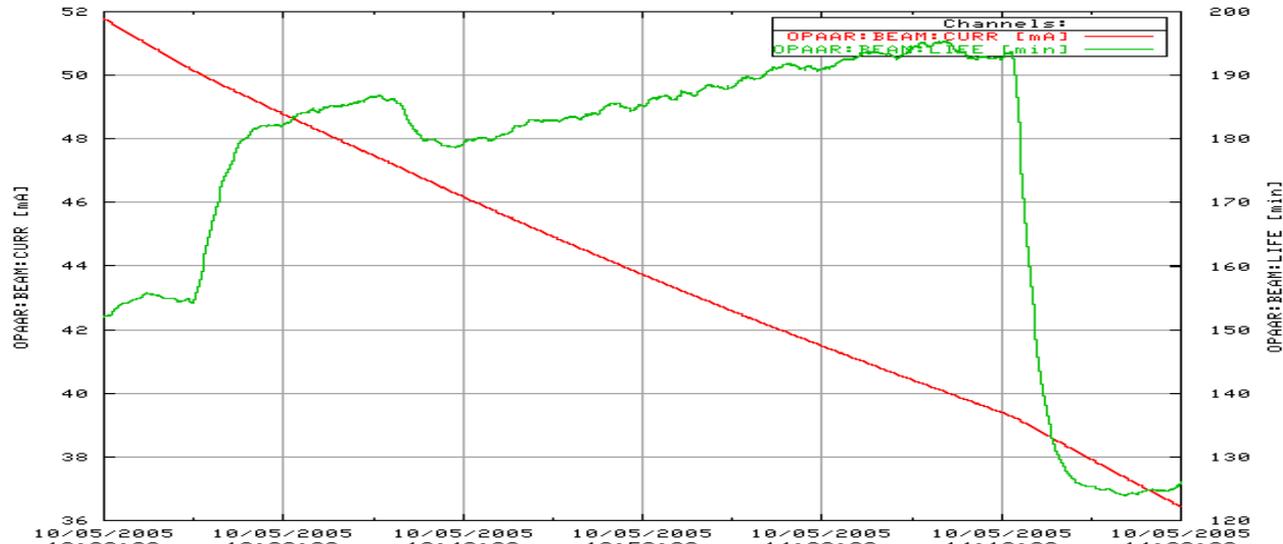
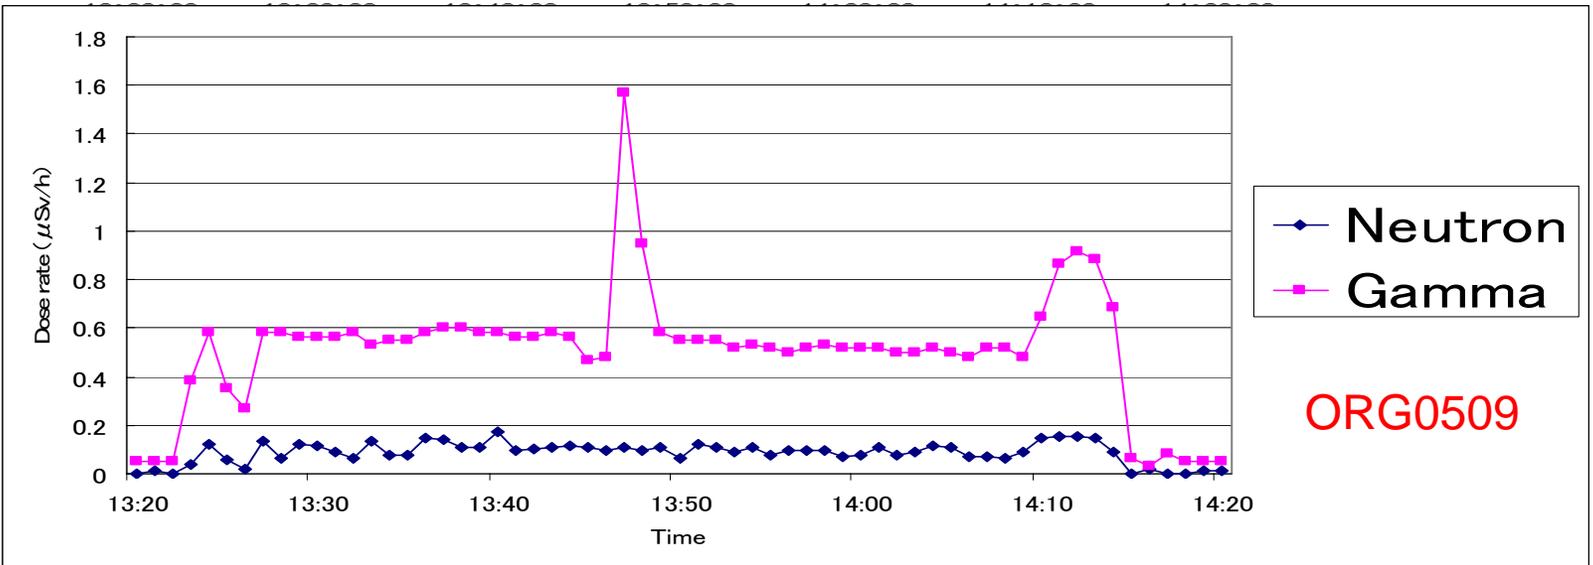
Beam lifetime and dose rate at ORG0509 during the measurement

- Changing the gap of NW14 insertion device narrowly often triggered the incident.
- The vacuum level was worse.
- The beam lifetime decreased.
- The dose rate around the beam line increased. NOT around other beam line.
- The dose rate returned to B.G. when the main beam shutter (MBS) was closed.

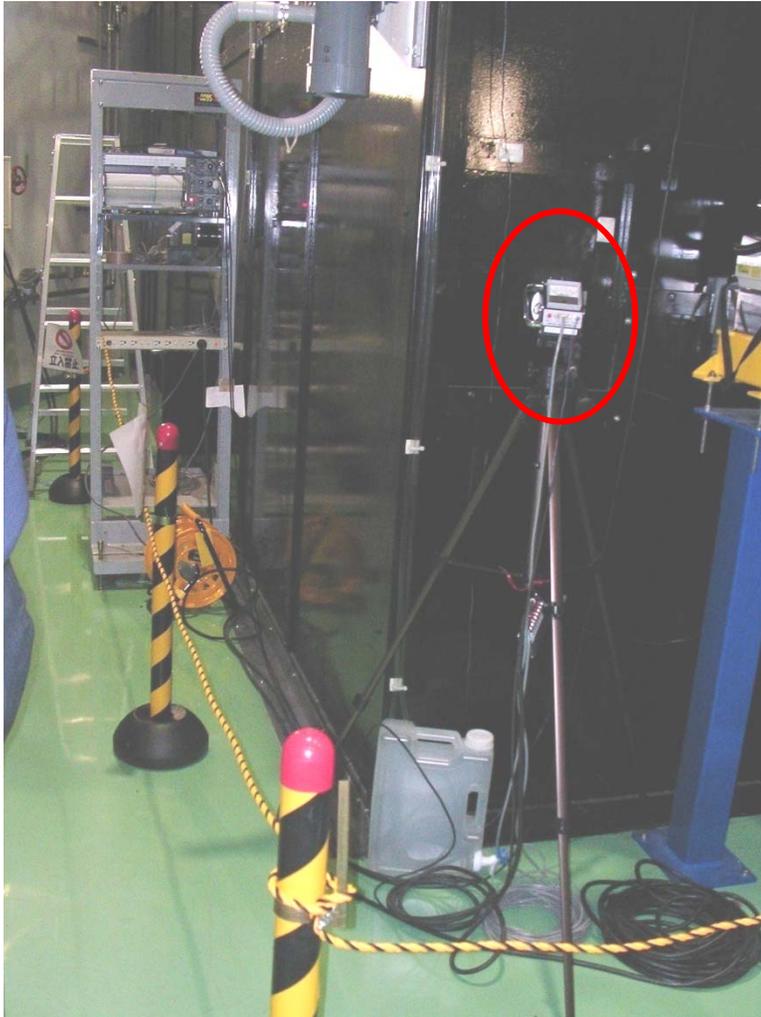
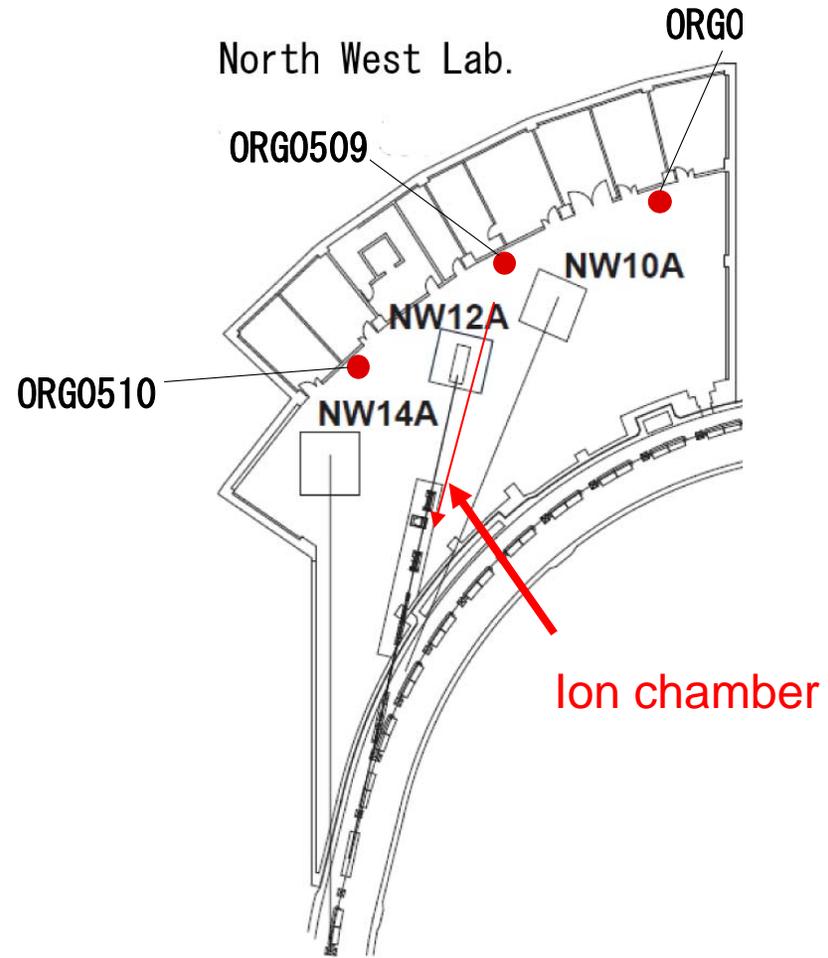
Ion chamber for interlock and replaced ORG0509

ORG0509 is not seen in this picture.
It replaced later.

- Lead blocks were installed in the optic hutch of the beam line.
- An ionization chamber for interlock was installed out of the optic hutch. It closes MBS when the dose rate exceeds $5 \mu \text{ Sv/h}$ and continues for 3 minutes.
- The area monitor was replaced to detect radiation effectively later.
