Radiation Safety issues for the PF-AR in KEK

H. Nakamura, Y. Namito, K. Iijima, K.
Takahashi and S. Ban

*High Energy Accelerator Research
Organization (KEK)*

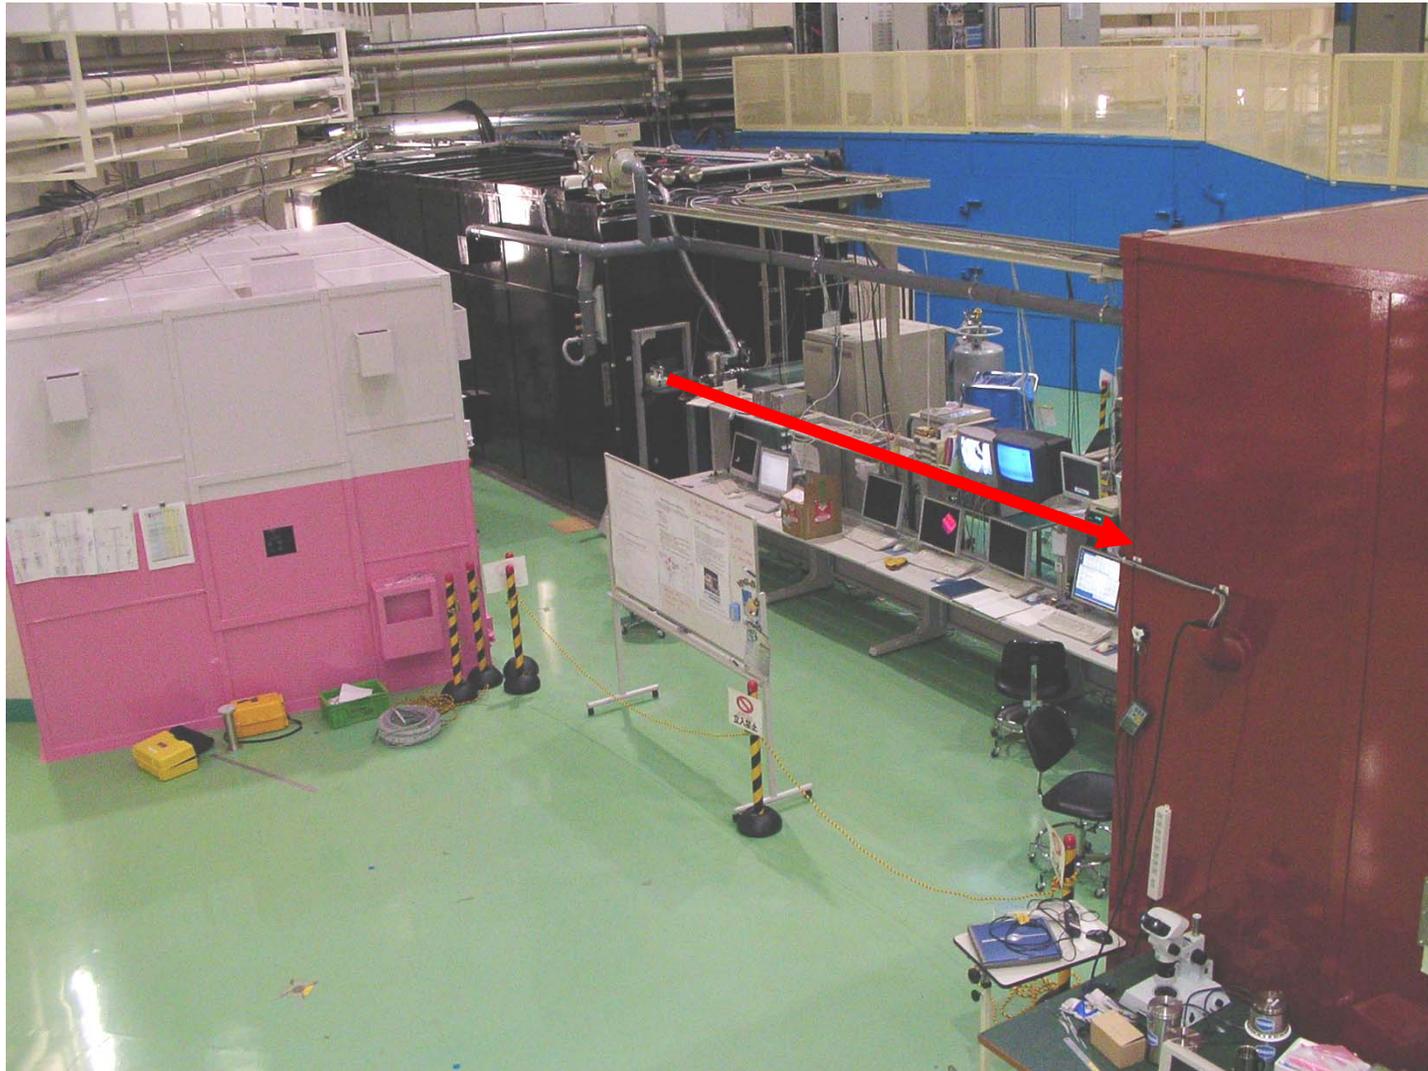
NW12 beam line

- Usual dose rate \doteq Background level
- Dose rate over the background level occurred when the **beam lifetime decreased**.
- Next slide shows example of this phenomenon occurred at the beam line NW12.

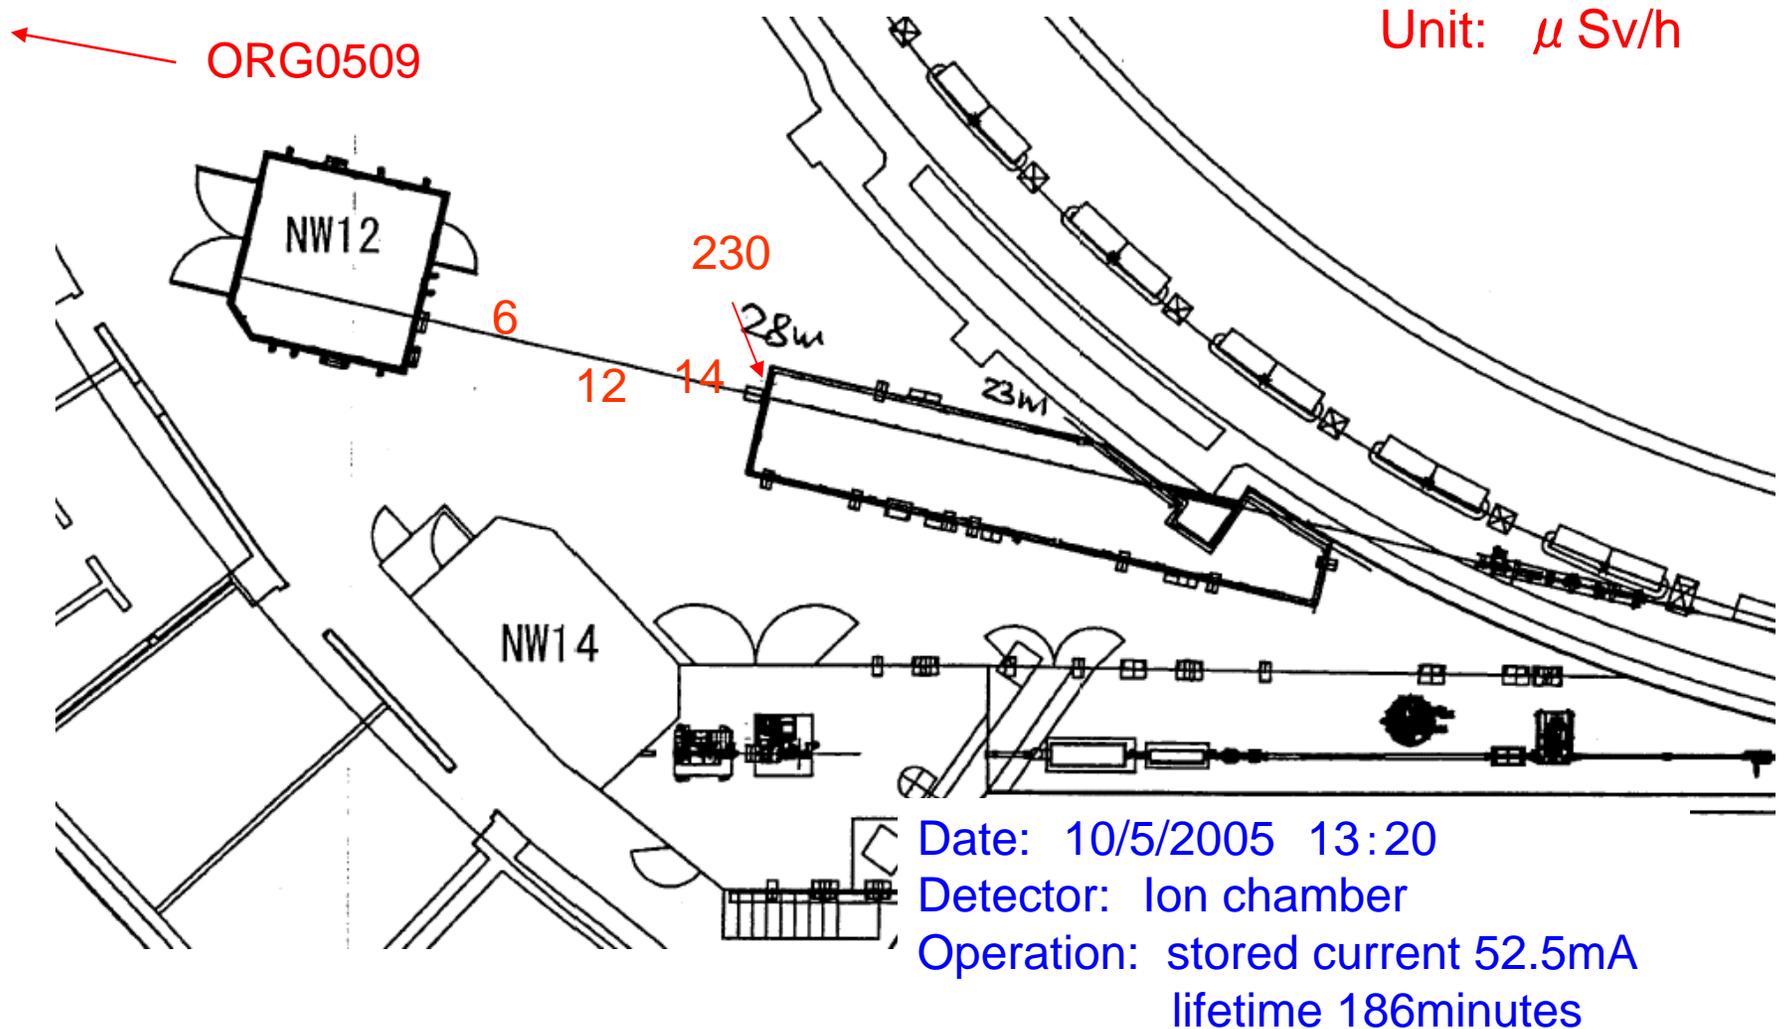
Radiation measurements around the beam line NW12

- Radiation source was the upper of NW12.
- Maximum dose rate at ORG509 was $1.6 \mu\text{ Sv/h}$.
- **ORG509** was **at long distance** from the radiation source. We tried to measure near the beam line.

- Lead blocks were installed in the optic hutch of the beam line.
- An ionization chamber for interlock was installed out of the optic hutch. It closes MBS when the dose rate exceeds $5 \mu \text{ Sv/h}$ and continues for 3 minutes.
- The area monitor was replaced to detect radiation effectively later.
