Review of Diamond SR RF Operation and Upgrades

Morten Jensen
on behalf of
Diamond Storage Ring RF Group

Cavity 2 Failure

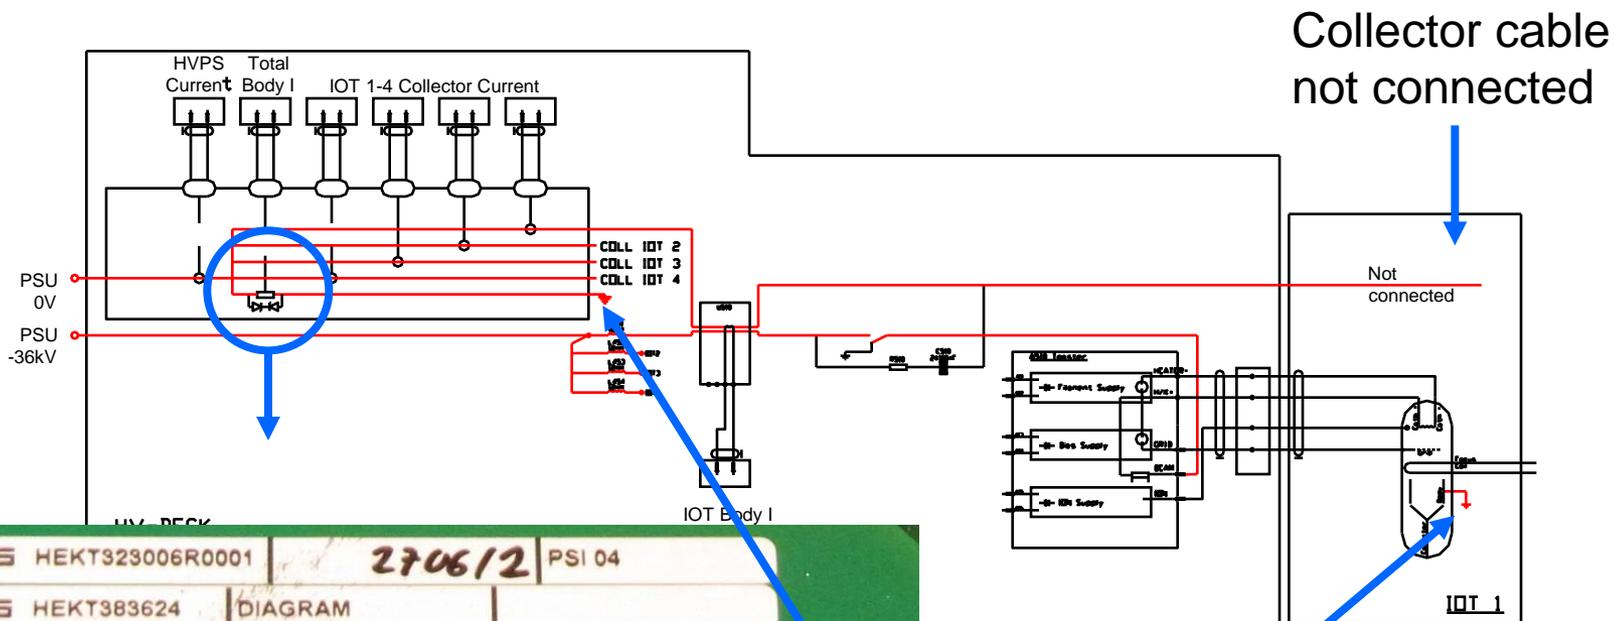
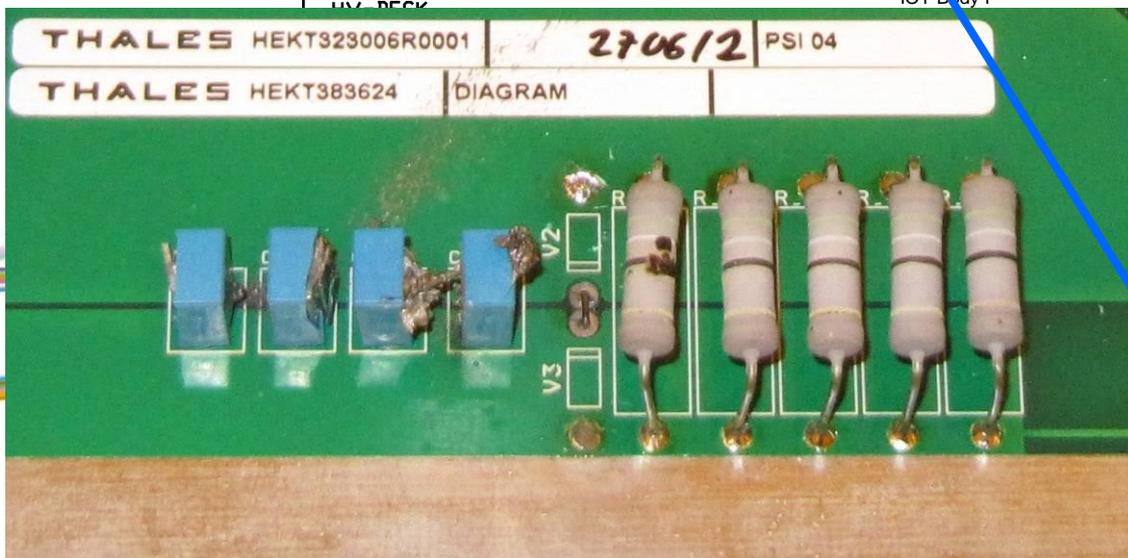
Original e2v configuration

Current measurement board affected by change from TED to E2V IOTs

-36kV return
Now through
IOT Body
and HVPS I
input

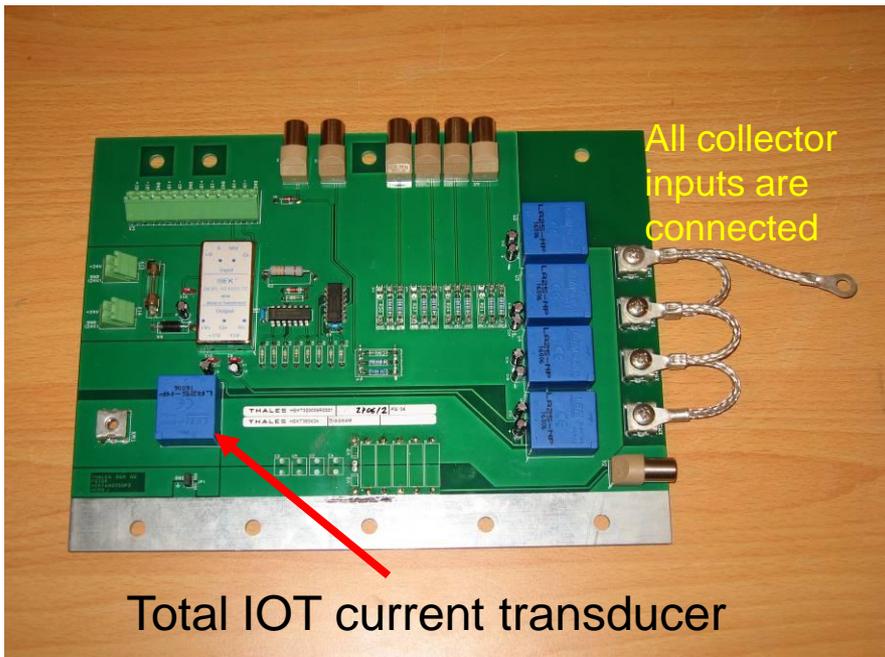
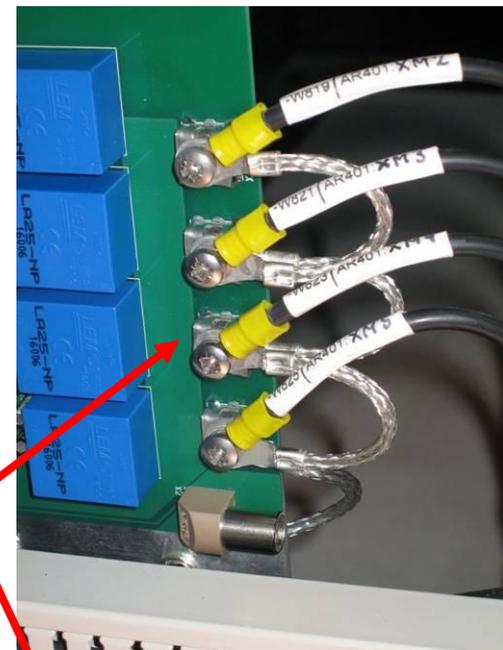
Current measurement board affected by change from TED to E2V IOTs

Earth current directed through IOT current transducers

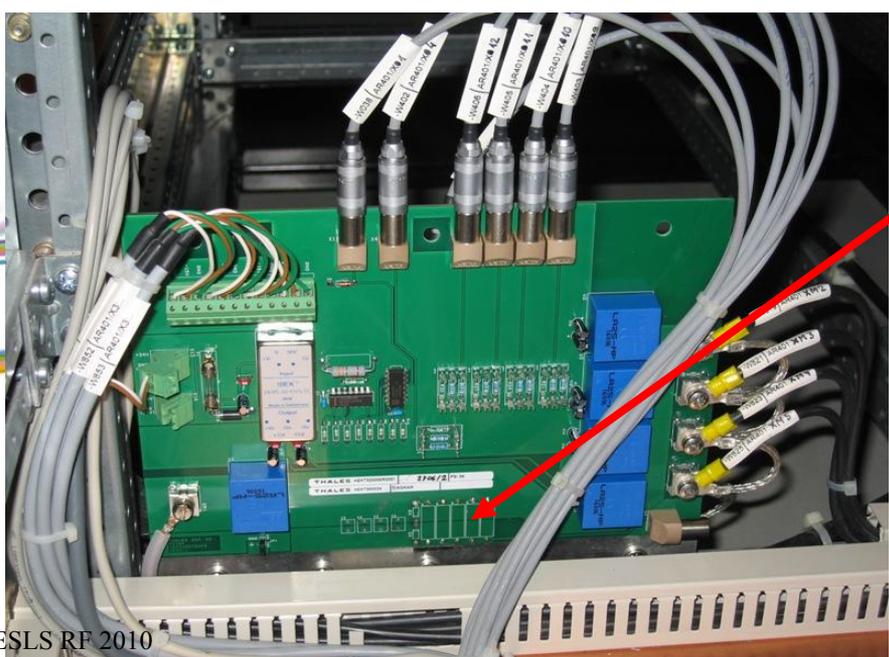
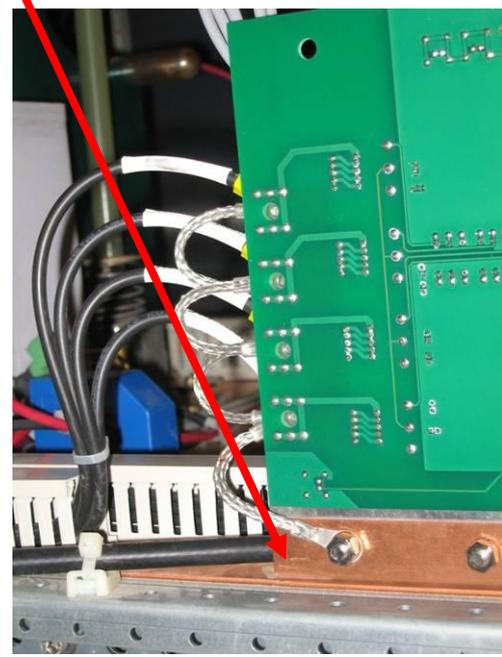
Body current components removed
